Manhole Inspection Summary

Manhole # S13II1029MH

Insp Date: **1/17/07 10:57 AM**

Location Address: **3023 OAKFORD AVE**

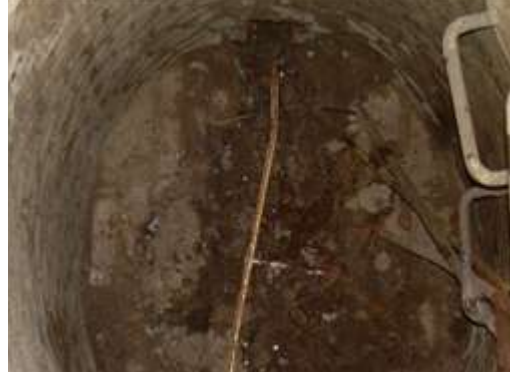
Top View

Channel debris. Corbel and Barrel infiltration.

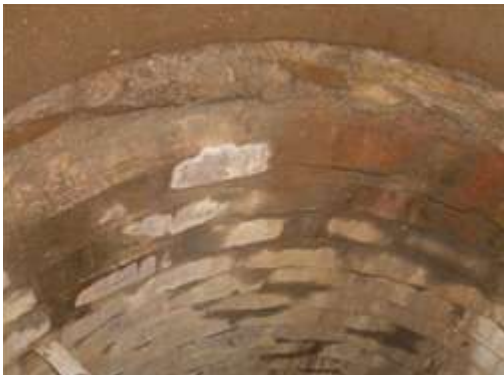
Defect

Frame leaks. Adjustment deterioration and infiltration. Corbel infiltration.

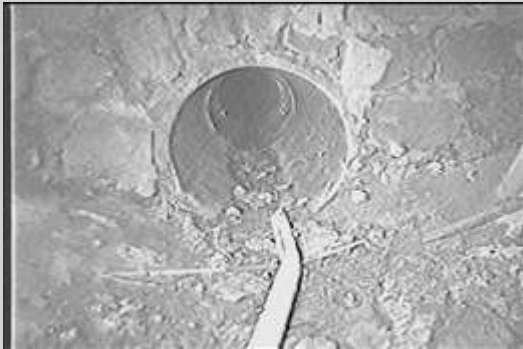
8 in. Circular Gravity Sewer
Pipe Out @ 12 O'Clock

Deposits: ☐ None ☐ Mud ☐ Sludge ☒ **Debris** ☒ **Grease**

Infiltration: **None** Pipe Seal Cond: **Cracked**
